Downtown People Mover (DPM) Winterization Test Demonstration: Otis Elevator

**Otis Elevator
Transportation Technology Division
P.O. Box 7293
Denver CO 80207**

**January 1982
Final Report**

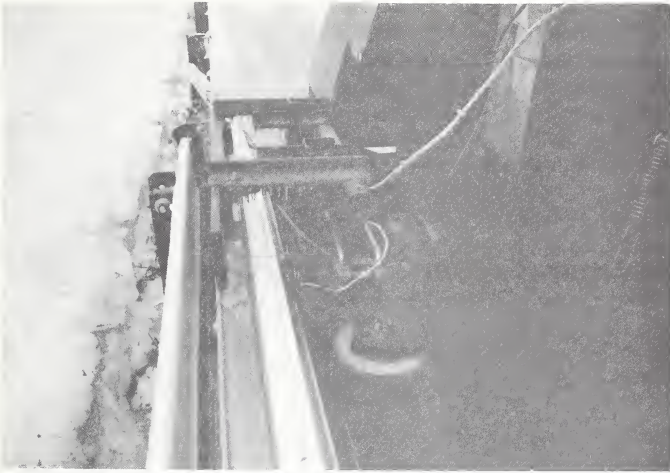
OTIS-TTD TEST VEHICLE REPRESENTATIVE DUKE HARDWARE

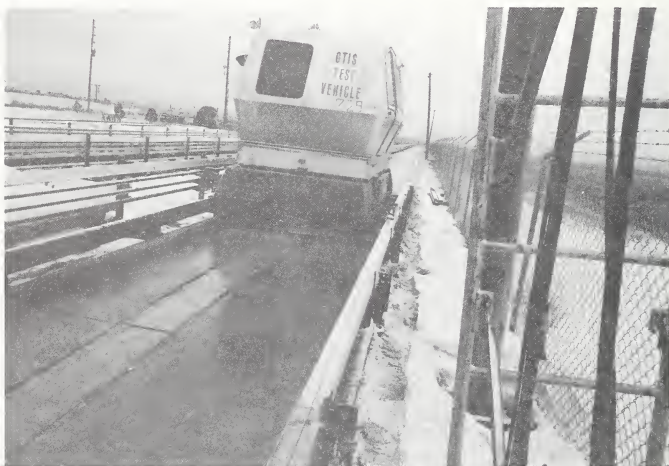
FULLY WINTERIZED TEST VEHICLE UNDERWAY IN ICE CONDITIONS

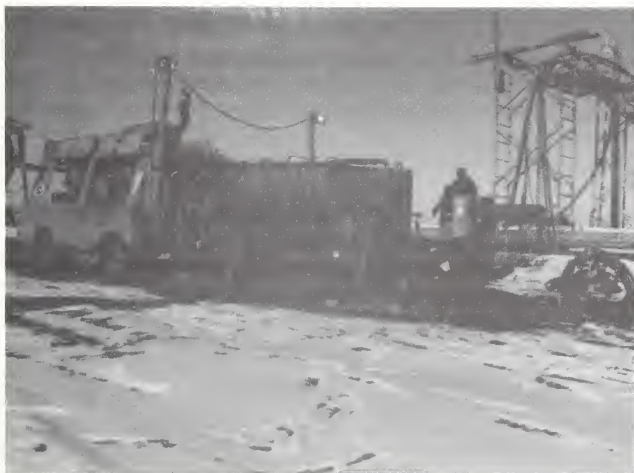
WINTERIZATION SNOWMAKING EQUIPMENT INCLUDING WATER PUMP,
AIR COMPRESSOR, WATER TANK, FUEL TANK AND AFTER-COOLER

abilities of up to 6000 gallons per hour were provided, along with a compressed-air supply of up to 750 cubic feet per minute. The program received an extremely late start during this season and weather conditions, for the most part, during the months of February and early March were not suitable for snowmaking operations. Some of the difficulties in producing the desired consistency of snow and accurately placing it on the guideway areas were due to insufficient air capacity for the snow guns and disturbances caused by prevailing winds. It was determined via experimentation (trial and error method) that winds over 3 mph and across the axis of the guideway would significantly influence placement of snow accumulations on the guideway surfaces.

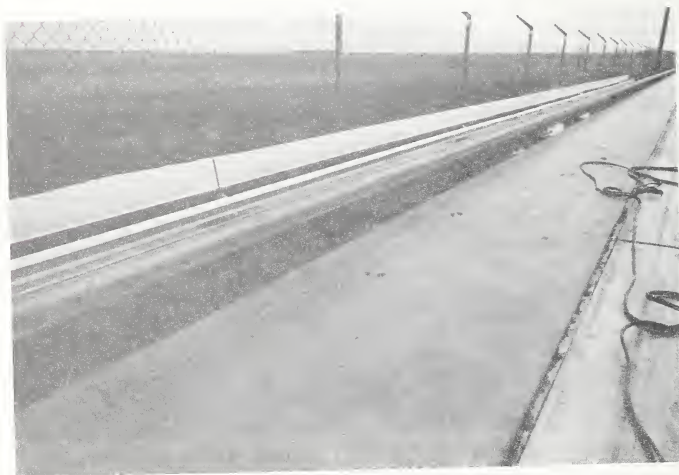
GUIDEWAY ANTENNA TEST SECTION DURING HEATER TEST ON RAILS

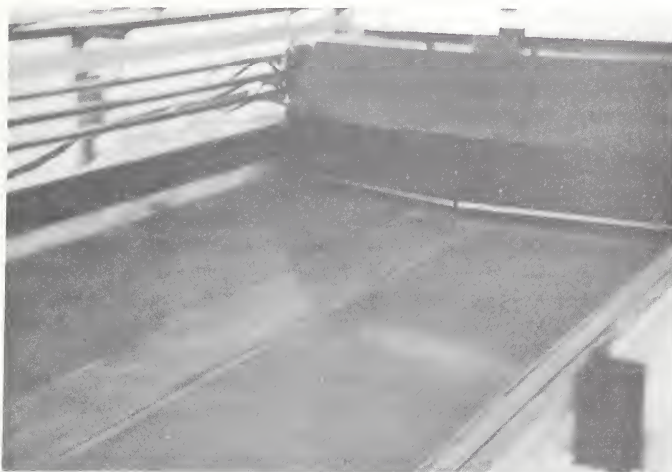
CLOSE-UP OF OTIS TEST VEHICLE SHROUD AND DEBRIS
GUARD INSTALLATION UNDERWAY IN ICE

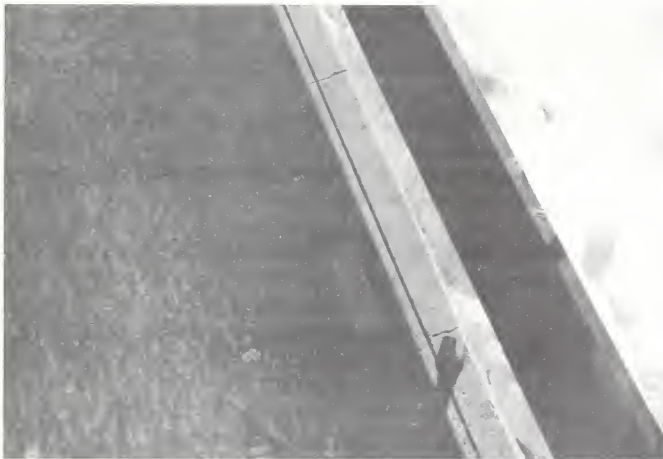
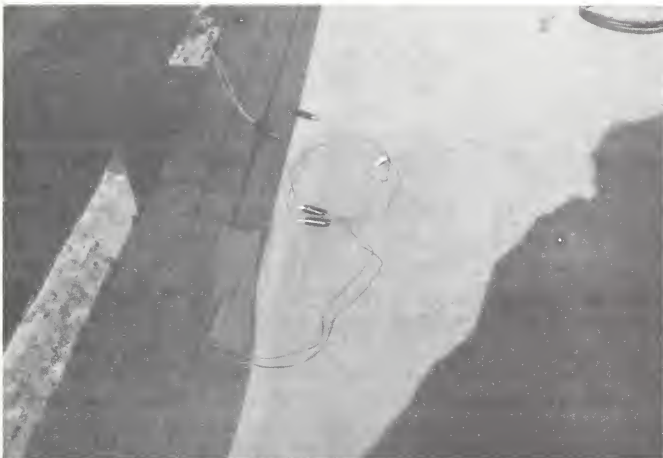
FIGURE 4-13. GUIDEWAY EMERGENCY BRAKE SURFACES WITH HEATER-WIRE SLOTS AND TEMPERATURE SENSORS

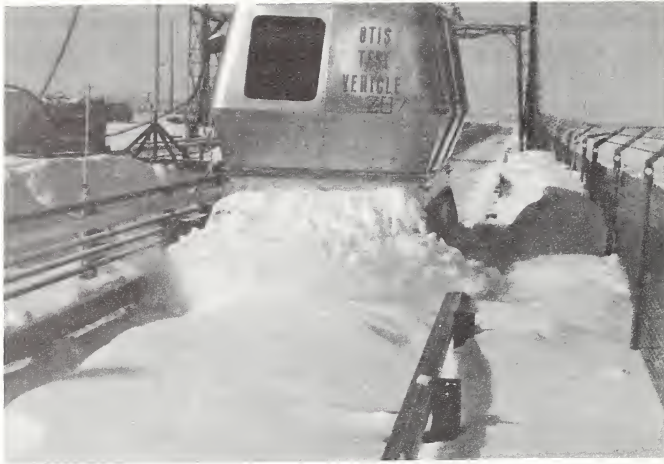
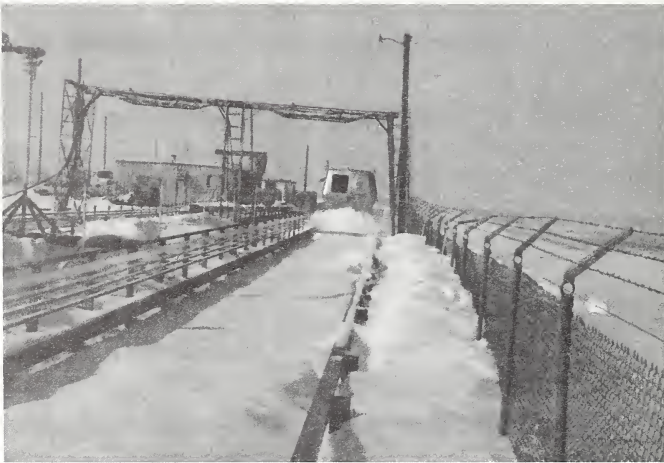
FIGURE 5-1. NORMAL VEHICLE SNOW REMOVAL

Ice removal capabilities were demonstrated on eight different occasions during the 1979-1980 portion of the OTIS-TTD winterization test and demonstration program. The ice accumulations were produced by spraying water on the guideway surfaces and related hardware and allowing this to freeze. The OTIS-TTD test vehicle was operated through this iced portion of guideway under full automatic control with debris guards and shrouds in place (normal configuration). The guideway heating equipment was activated on the brake surfaces, power rails, guidance/ground rail, and signal rail prior to operations. In all cases, no operational difficulties were ever encountered in operating the Otis test vehicle through these particular conditions. The off-guideway accumulations of freezing rain or sleet usually totaled in excess of 1 inch, but the total accumulation that remained on the reaction rail and flying surfaces never exceed 0.75 inch. No attempt was made to remove this remaining ice accumulation. When daytime temperatures rose above freezing, the ice accumulation on the guideway was removed completely by the vehicle during automatic

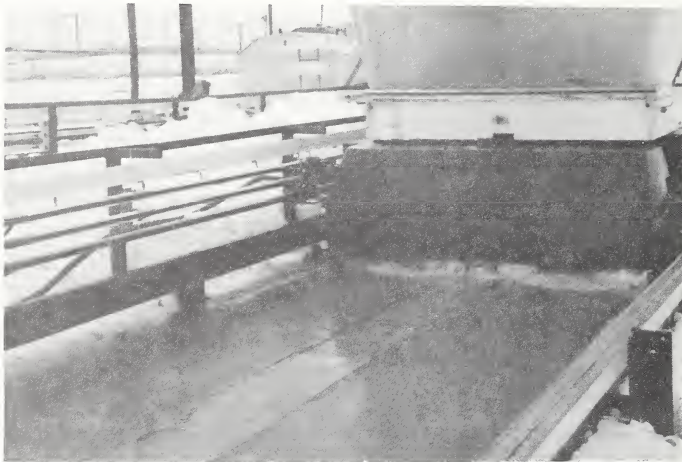
CLOSE-UP SHOWING THE ACTION OF THE DEBRIS GUARD

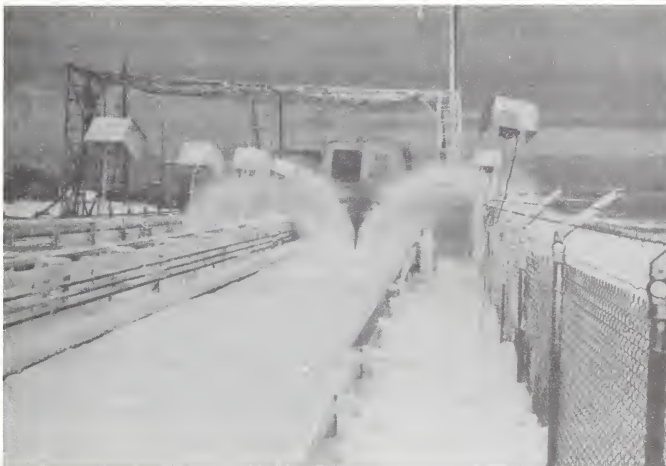
VEHICLE SNOWPLOW OPERATIONS IN 10 INCHES OF SNOW

After the successful snowplow operations it was decided to produce heavier accumulations of snow. On January 22nd, snow-making operations continued until accumulations on the guideway measured from a low of 8.5 inches to a maximum depth of 25 inches. The moisture content was measured at four different locations within the test area and ranged from 36 to 45 percent. Although the accumulation and moisture content were far in excess of the test objective (16 inches at 30 percent), the vehicle with the snowplow was run into the snow accumulations. This particular snow was described as igloo-type snow, very blocky and chunky, extremely hard. If this snow could be cleared, any snow condition imaginable could be handled by the vehicle plow. The vehicle entered the snow area at 20 fps and removed snow for approximately 75 feet. Power collector contact was lost from the rails resulting in a vehicle power distribution fault. The vehicle was again operated into the snow accumulations and removed 35 feet of snowfall, was backed out and on a third run, the remainder of the snow accumulations were removed. Figure 5-5 shows this snow removal. The vehicle snowplow operation was extremely successful in clearing the guideway surface and removing the snow accumulations of this particular magnitude and density. It was evident after this particular run that the snowplow would operate more efficiently and with better results at higher velocities. In addition, it was felt that improvements could be made to the snow plow to reduce the amount of snow left in front of the guidance rails and power rails after plowing. A modified wing was added to the snowplow to clear the snow accumulations to within approximately 1 inch of the power rails.

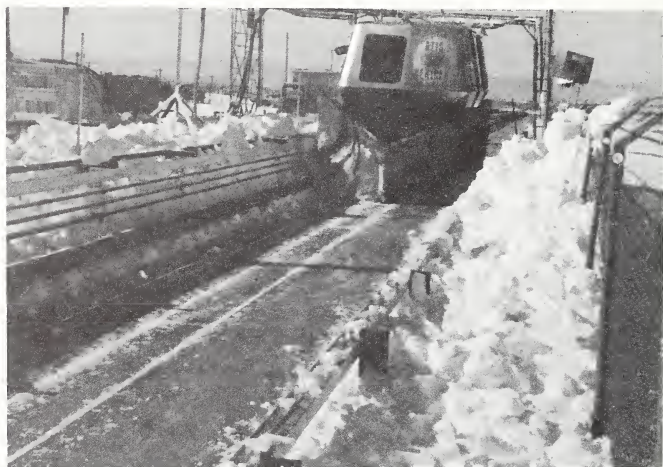
EXCELLENT GUIDEWAY CONDITION AFTER THREE RUNS

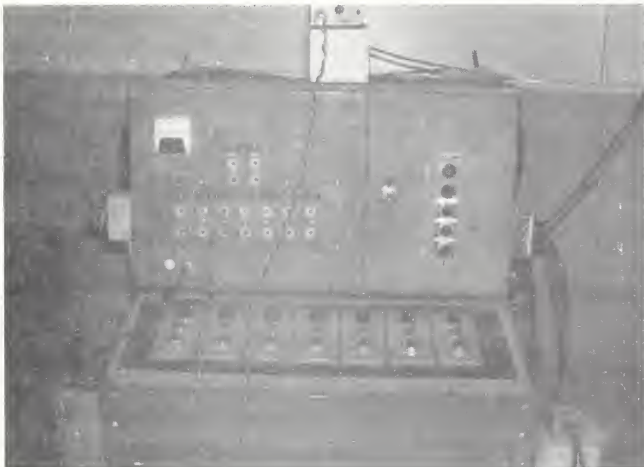
WINTERIZATION GUIDEWAY HEATING CONTROL
AND MEASUREMENT CONSOLE

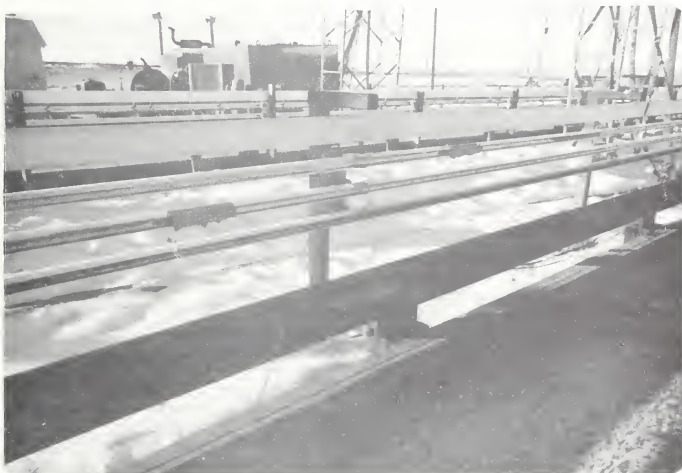
WINTERIZATION TEST AREA POWER DISTRIBUTION RAILS
WITH COVERS AND TEMPERATURE SENSORS

Small differences in the rail temperatures were noted with and without the insulative covers on the power distribution rails. Where the winds caused rail temperatures to drop, small improvement was attributed to the ability of these covers to retain the heat within the rails. Power rail insulative covers may provide some protective contribution in winds above 20 mph. Heated power and ground rails provided reliable operations in all winter conditions tested after 20 to 30 minutes of warm-up time. A specific incident of power rail icing or related failure never occurred on the heated rails in the operating system.

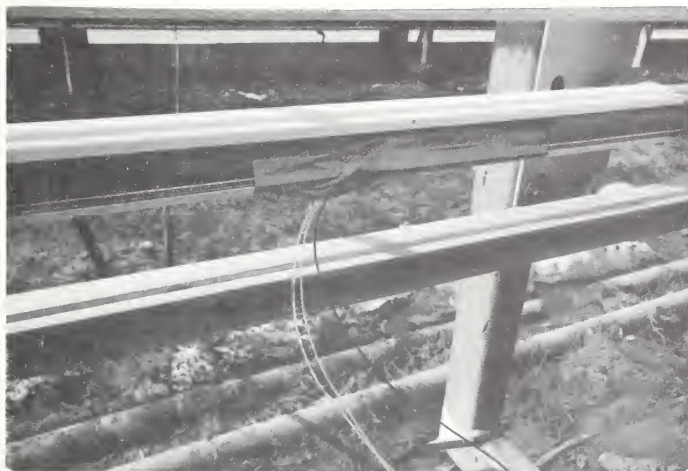
TEMPERATURE SENSOR INSTALLATION ON PHASE B POWER RAIL

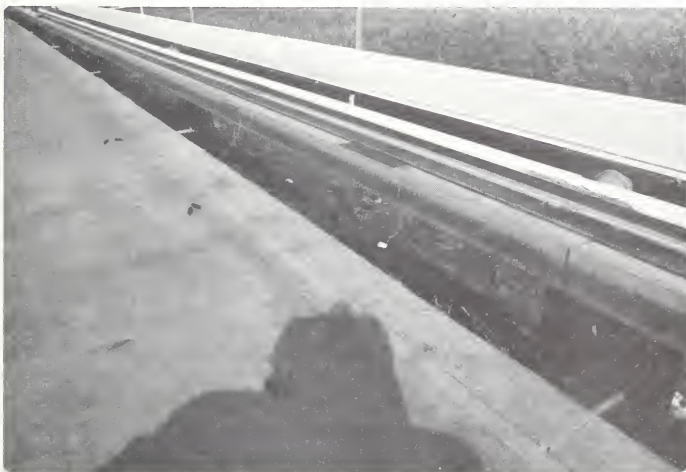
TEMPERATURE SENSORS INSTALLED ON DUKE (DPM)
GROUND/GUIDANCE RAIL

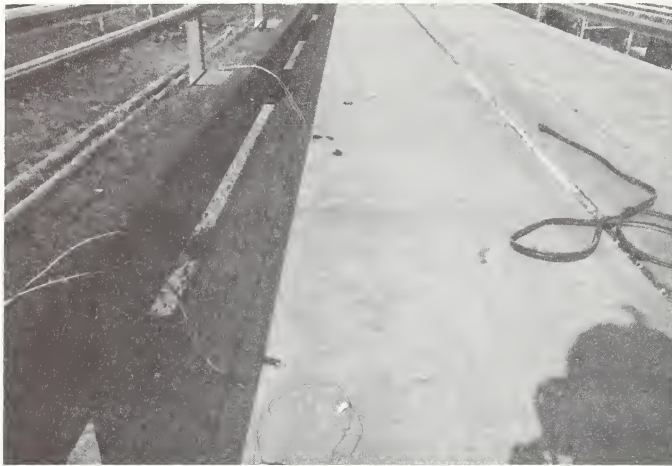
FIGURE 5-17. EMERGENCY BRAKE SURFACE

WINTERIZATION TEST AREA
SOUTHSIDE EMERGENCY BRAKE SURFACE

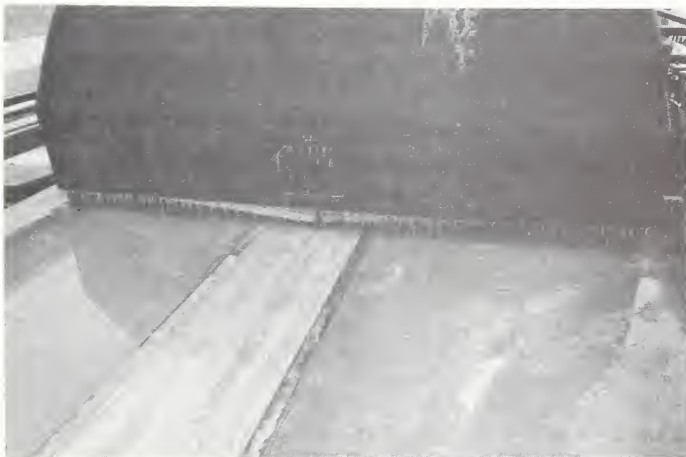
VEHICLE STARTS TO OPERATE AUTOMATICALLY
OUT OF ICE STORM

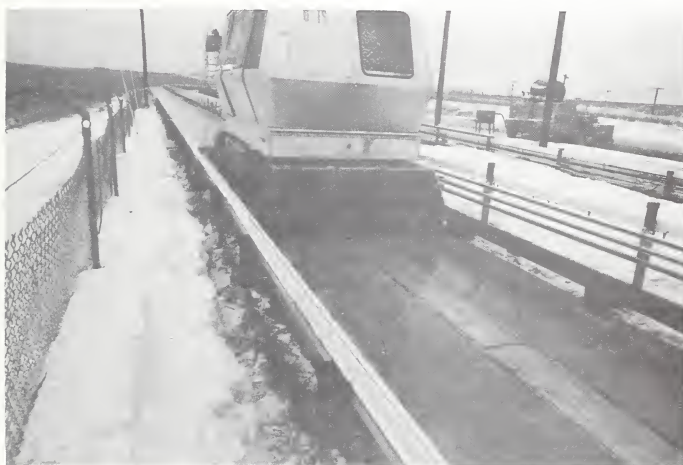
VEHICLE UNDERWAY WESTBOUND AFTER ICE STORM

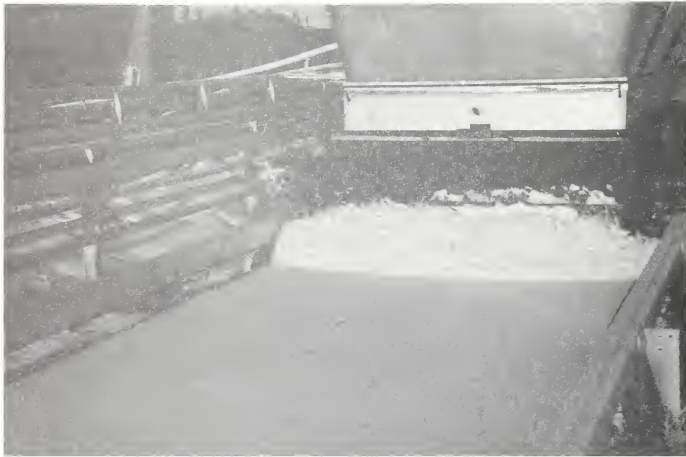
VEHICLE PUSHING SNOW ASIDE AND
POWER COLLECTOR RUNNING IN SNOW

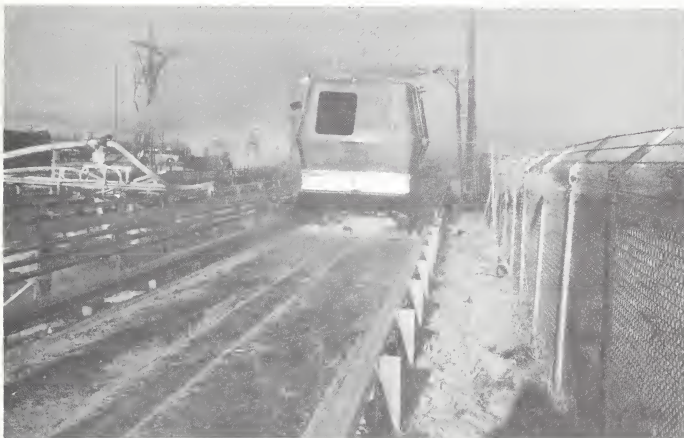
GUIDEWAY CONDITION AFTER CIRCULATION

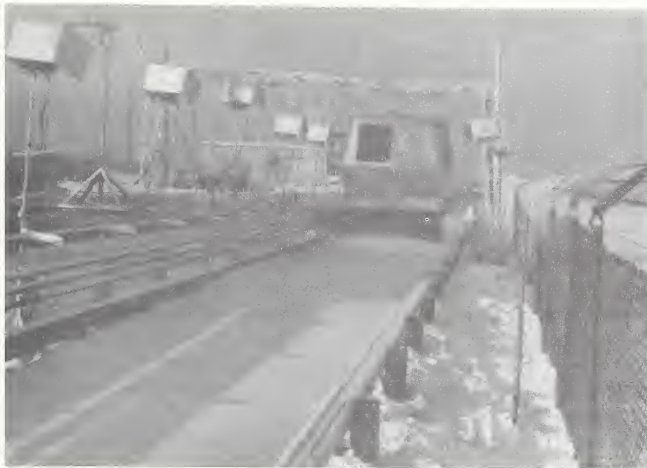
1ST NORMAL VEHICLE RUN IN 1980, USING
NON-WINTERIZED SHROUD

On January 18, 1980, snowmaking operations were commenced at 5:35 in the morning. The vehicle was circulated through the snow accumulations in the test area for a total of five runs, removing snow accumulations ranging from 1 to 1.5 inches each time. All runs were conducted without any adverse effects as the vehicle was successfully operated through a simulated winter storm event of wet snows with a moisture content of 25 to 35 percent and a total off-guideway accumulation of 7 to 8 inches. After completion of the last circulation run, the vehicle was operated in the automatic mode through the test area and performed an emergency brake stop, with normal deceleration levels and stopping distances. Figure 9-4 shows the photographic documentation of the system-level vehicle circulation tests performed on the 18th of January.

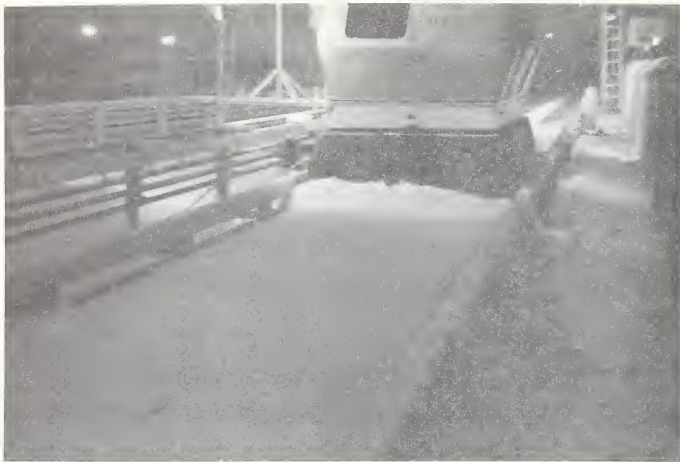
VEHICLE CIRCULATION ON 1-17-80
REMOVING INITIAL SNOW COVER

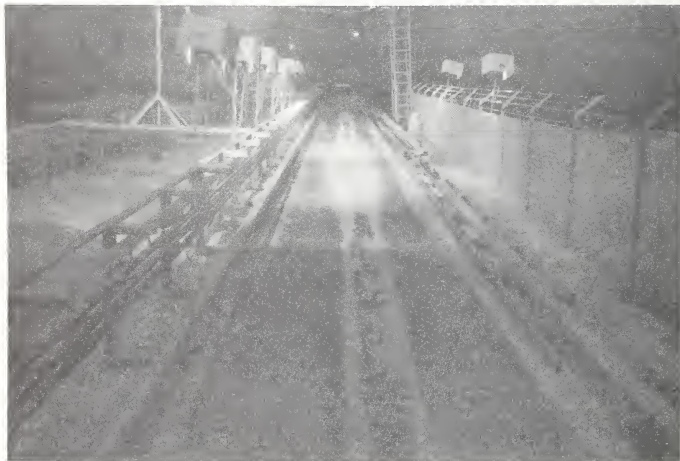
CLEARED GUIDEWAY AFTER ABOVE RUN

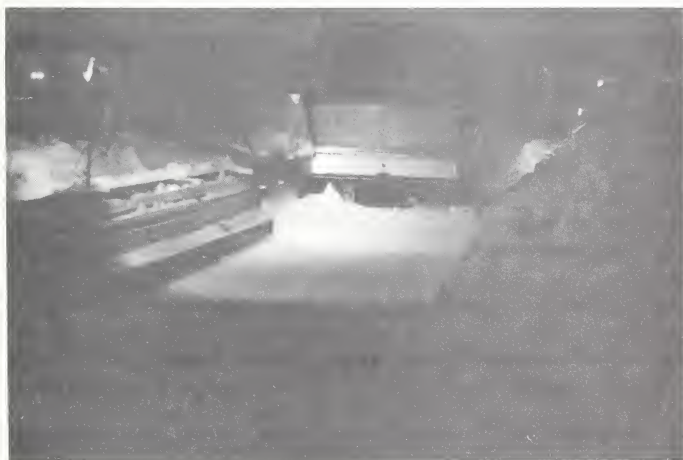
SYSTEM-LEVEL RUN IN MAN-MADE SNOW, OFF-GUIDEWAY SNOW
ACCUMULATIONS WERE 40 INCHES IN LAST WEEK

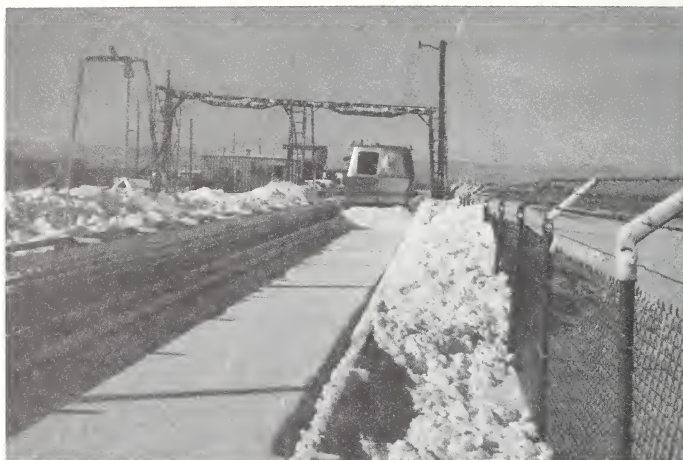
1 TO 1.5 INCHES ON GUIDEWAY SURFACE

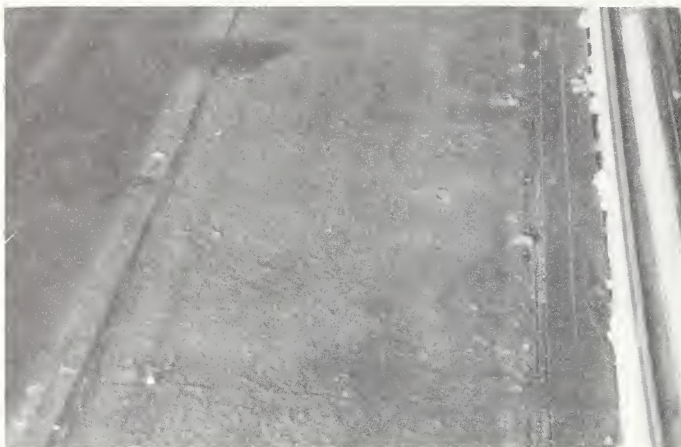
CLOSE-UP OF ICE COVERING ON
GUIDEWAY FLYING SURFACE

Three additional test days of icing conditions were produced on the 1st of February, the 29th of February, and the 12th of March. All ice accumulations that were produced presented no problem to vehicle operations. Of an interesting note were the rime ice conditions that were produced on the 12th of March. They were negotiated successfully on four different test runs, with the total guideway accumulation varying from 0.25 to 0.5

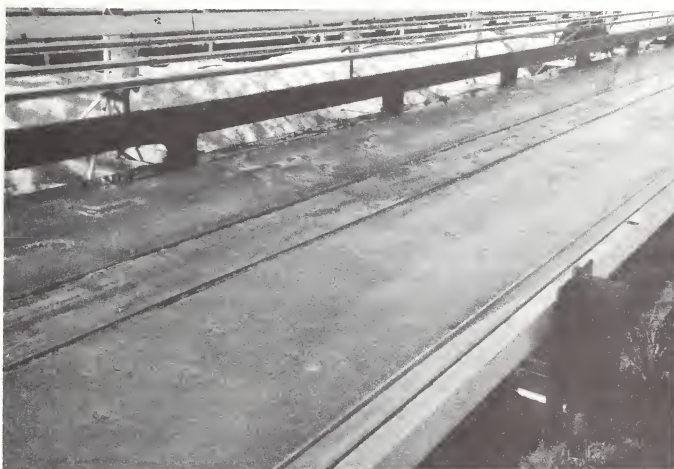
GUIDEWAY CONDITION AFTER ABOVE RUN
